Going to Extremes

Expertise and slope stabilization systems handle some of the toughest sites imaginable.

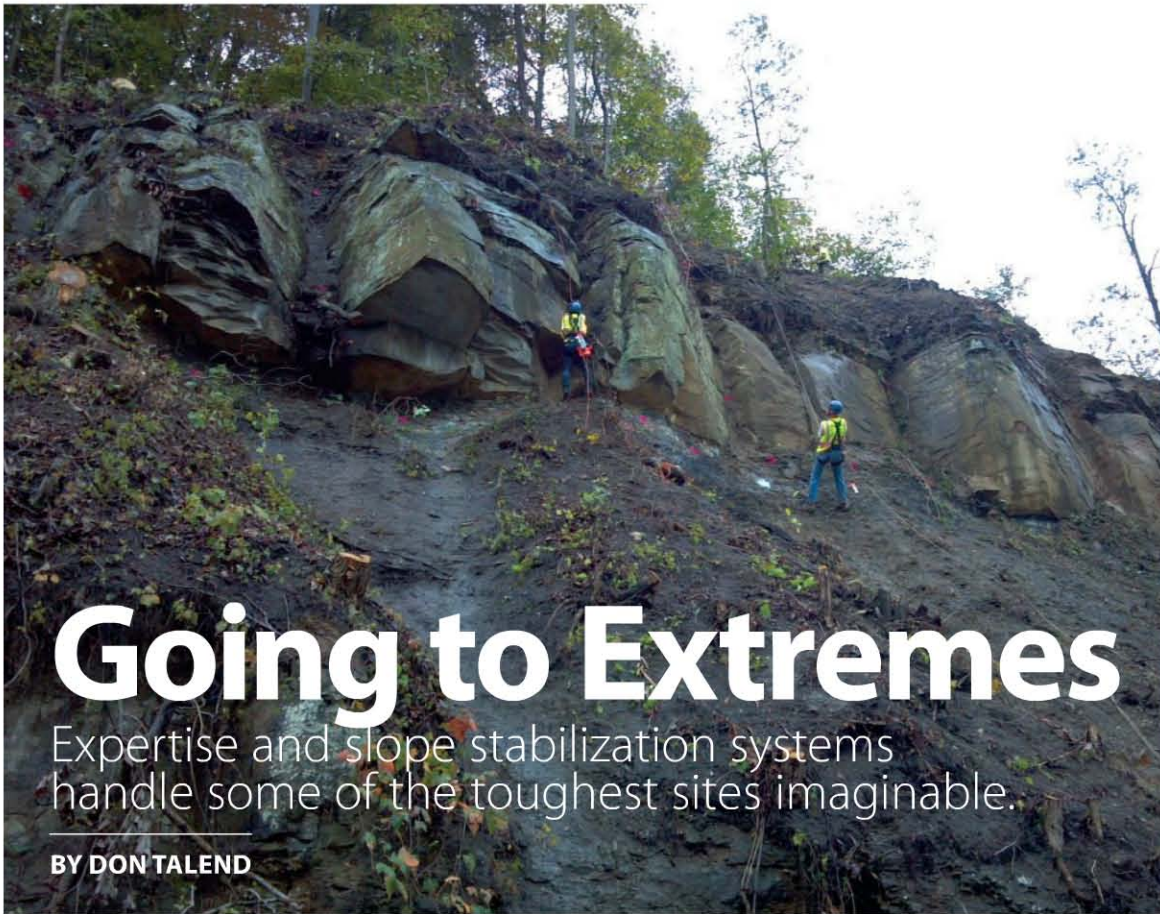
AMERITECH SLOPE CONSTRUCTORS

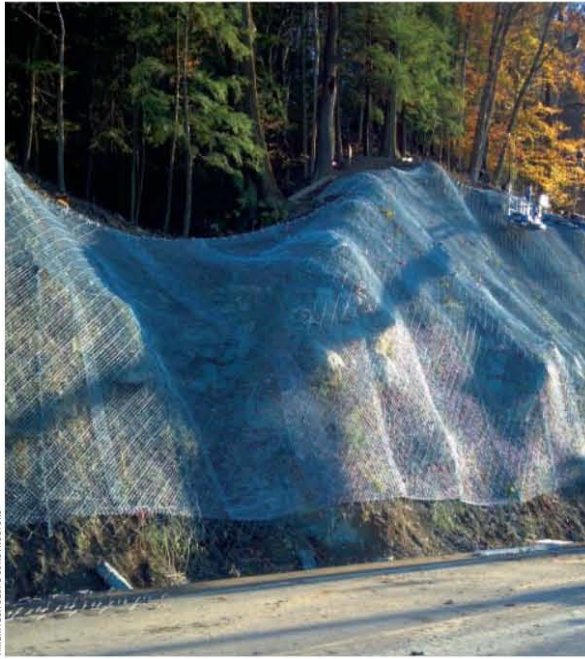
For the drape, cable anchors were installed at the top of the slope and grouted into place.

Route 19 was closed along the stretch where the work was done, and traffic was detoured. On the \$1.5 million Weston project, holes were drilled into the large block outcroppings, threaded bars were inserted into the holes and grouted into place, Spider wire was placed over the bar anchors and tensioned using the spike plates, and cables were stretched and tensioned along the Spider wire boundaries. For the drape, cable anchors were installed at

the top of the slope and grouted into place. The backing mesh and rolled cable nets were installed in panels and clipped together at each edge. A top boundary cable helps support the load

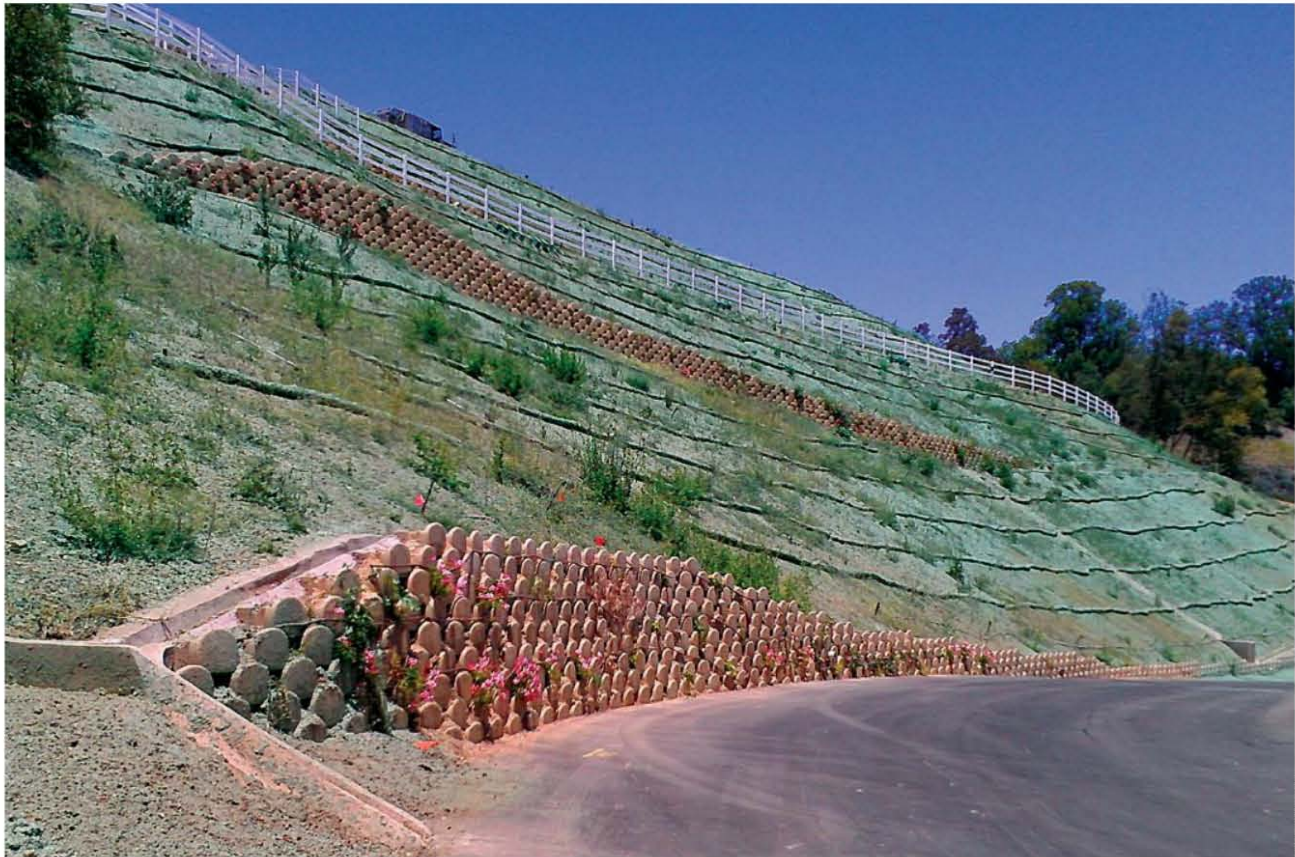
The slope is seen as it appeared following remediation and with the creation of a safer roadway at the bottom.

The site was divided into two near-level graded lot areas, one 4.7 acres, the other 2.7 acres. Graded slopes of up to approximately 145 feet were constructed at inclinations as steep as 1.7:1. In total, eight MSE toe-of-slope and mid-slope walls were also constructed throughout the property. In addition, a bridle trail and two driveways were constructed to provide access to the two lots. Drainage at the site is now controlled by surface flow and improved surface and underground drainage devices. Septic systems were constructed in the corners of each lot area to minimize any future impact of these systems on the lots or adjacent slopes. The existing house and all associated structures and improvements were completely demolished and removed offsite. The landscaping plan included hydroseeding of the slopes.
